DANGERS OF DOUBLE CLAMP BANDED SPRING BRAKES

By MGM Brakes

INDUSTRY SAFETY REMINDER: The Danger of Double Clamp Banded Spring Brakes

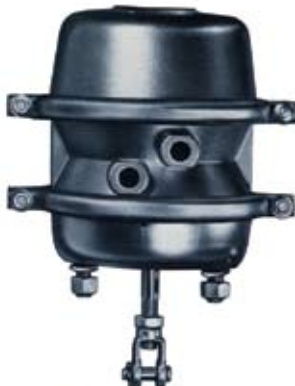
IMPROPER SERVICING OF A DOUBLE CLAMP BANDED SPRING BRAKE ACTUATOR MAY RESULT IN SEVERE PERSONAL INJURY DUE TO AN UNINTENTIONAL SEPARATION OF THE HEAD FROM THE BASE OF THE UNIT.

**Spring Side
Clamp Band**

**Service Side
Clamp Band**

BE SURE TO PROPERLY "CAGE" THE SPRING IN THE SPRING PARKING SIDE ON ALL DOUBLE DIAPHRAGM SPRING BRAKE ACTUATORS - EVEN "TAMPER RESISTANT" MODELS - BEFORE ATTEMPTING ANY SERVICE ON THEM.

DO NOT ATTEMPT TO REMOVE OR LOOSEN THE SPRING PARKING SIDE CLAMP BAND ON A DOUBLE CLAMP BANDED SPRING BRAKE ACTUATOR UNDER ANY CIRCUMSTANCE.
