Corrosion Fighter Technology

Main Cause of Corrosion on Vehicles

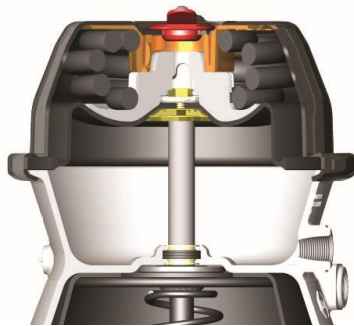
[Guide depicted in orange for visual purposes only]

The composite guide material prevents metal to metal contact between the end of the power spring and the head of the brake, effectively “breaking the circuit”, therefore; slowing the corrosion process and reducing corrosion related brake failures.

The key to extending the life of the spring brake is to prevent corrosion from attacking the spring. The spring is coated with a barrier that effectively prevents corrosion. Keeping the barrier intact is essential to preventing corrosion. One way to reduce the effects of this “corrosive attack” is to break the electrical conductivity between the parts by changing one of the existing components to a non-conductive material. This is what MGM Brakes engineering has done by designing a spring guide constructed from heavy duty, non-conductive composite material.

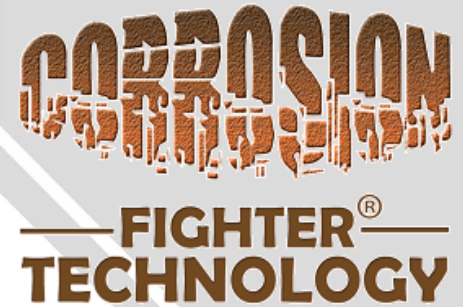
Corrosion Fighter Technology

In addition to constructing the guide from composite material, MGM Brakes made other design changes that significantly improve power spring life by preventing damage to the power spring's protective coating. This was accomplished by eliminating contact between the active spring coils at all times. All this was done without increasing the overall size of the brake.

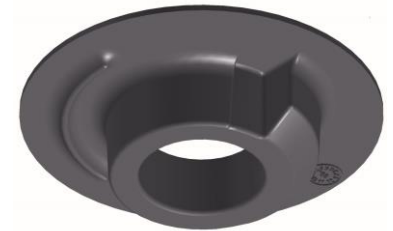
Corrosion Fighter technology is a patented MGM Brakes exclusive design that increases power spring life by reducing the internal effects of electrolysis. The composite spring guide assures proper alignment of the piston. The composite guide is constructed of heavy-duty non-metallic composite material which slows the corrosion process and reduces corrosion related failure.

The polymer spring guide also ensures precise alignment of the power spring inside the brake. The accurate alignment of the head side of the power spring compliments the MGM Brakes patented Center Hole Diaphragm (CHD) design providing longer center seal and power spring life.
