DANGERS OF DOUBLE CLAMP BANDED SPRING BRAKES

By MGM Brakes

INDUSTRY SAFETY REMINDER: The Danger of Double Clamp Banded Spring Brakes

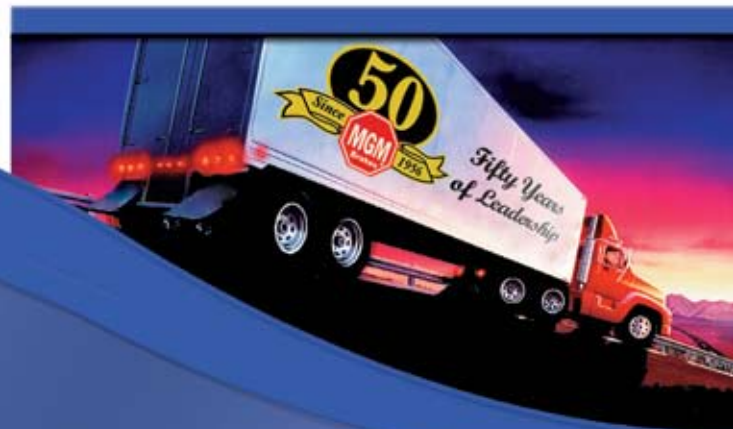
Before 1989 double diaphragm spring brake actuators were manufactured using two clamp bands; one to seal the service side and one to seal the spring parking side. At one time both sides of these units were considered "serviceable", meaning that if either side failed the clamp band could be removed, the diaphragm or other components could be replaced, and the unit continued in service as repaired.

While removing the clamp band on the service side of a double diaphragm spring brake actuator carries little or no risk, experience showed that all too often technicians did not follow the required safety procedures when removing the clamp band on the spring parking side, resulting in a potential for severe personal injury. If the powerful spring in the spring parking side is not properly "caged" before the clamp band is removed the spring can propel components of the assembly with great force, potentially causing severe personal injury.

IMPROPER SERVICING OF A DOUBLE CLAMP BANDED SPRING BRAKE ACTUATOR MAY RESULT IN SEVERE PERSONAL INJURY DUE TO AN UNINTENTIONAL SEPARATION OF THE HEAD FROM THE BASE OF THE UNIT.

**Spring Side
Clamp Band**

**Service Side
Clamp Band**

DO NOT ATTEMPT TO REMOVE OR LOOSEN THE SPRING PARKING SIDE CLAMP BAND ON A DOUBLE CLAMP BANDED SPRING BRAKE ACTUATOR UNDER ANY CIRCUMSTANCE.
